MONITORING THE INTEGRITY OF DEEP WATER WELLS BEHIND CASING

SMI and MI@NUS workshop
19 November, 2014

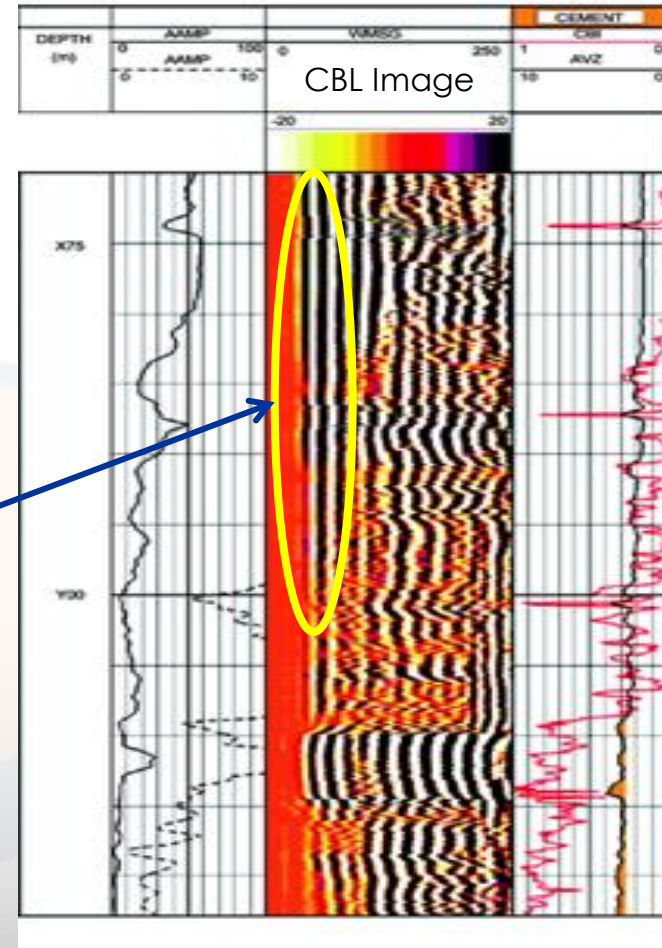
Current Cement Bond Log lacks resolution and gives only qualitative results (attenuation, bond quality) with limited azimuthal resolution

Bad cement

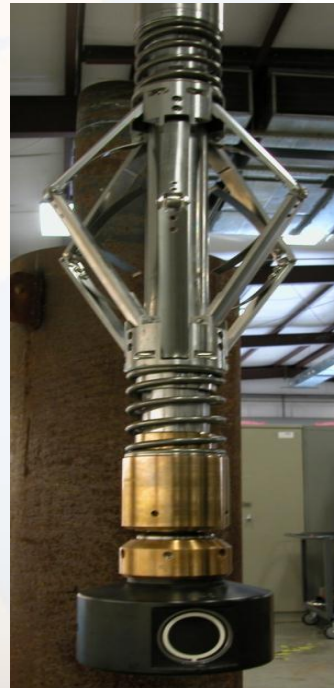
Ultrasonic tool CAST™

Ultrasonic pulse-echo tools provide image and approximate impedance at the casing/cement interface, as well as casing thickness, with 360° azimuthal resolution
